1 Installation and Operating Experience

Using the VM600 online Protection and Condition Monitoring System to monitor the supervisory parameters and the rotor air gaps at SENECA pumped storage facility in Warren, Pennsylvania.

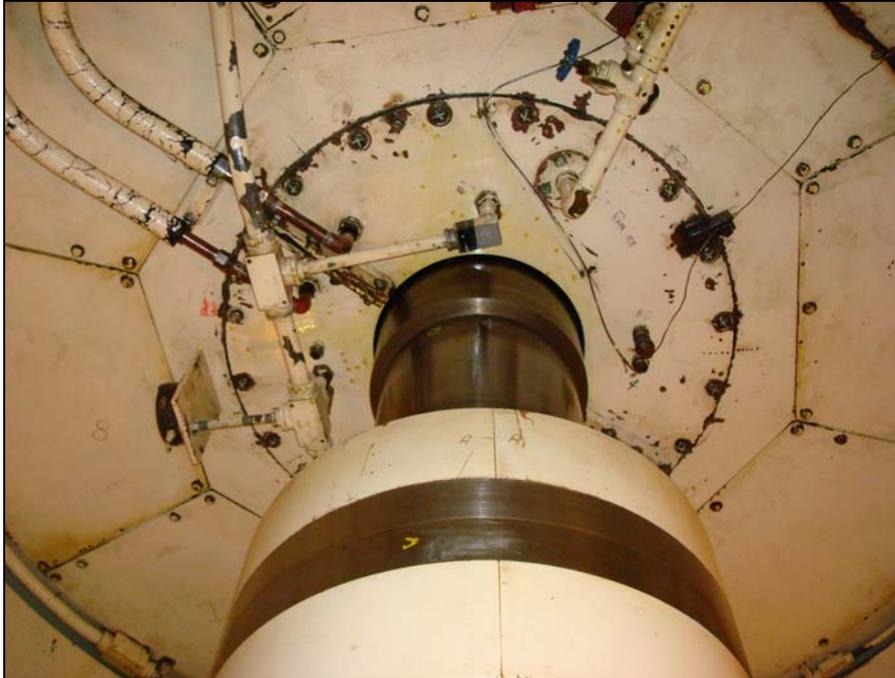
One of the challenges faced by Zeefax during this installation was the lack of detailed mechanical component and assembly drawings relating to the installed Hydro Units. Although some drawings were available, they had been hand drawn on paper in the early 1960s, and many were in poor condition. Because of this, in most cases, the required dimensions, hole centers and other details had to be measured or derived directly from the units.

Fig 7: Lower guide bearing as found

Using careful measurement, trigonometric extrapolation and photography, a series of mechanical drawings were constructed for each bearing. These drawings were then used to assist with the detailed design of the probe mounting brackets, to help locate the positions of various access points which were required and to establish final mounting positions of the transducers.

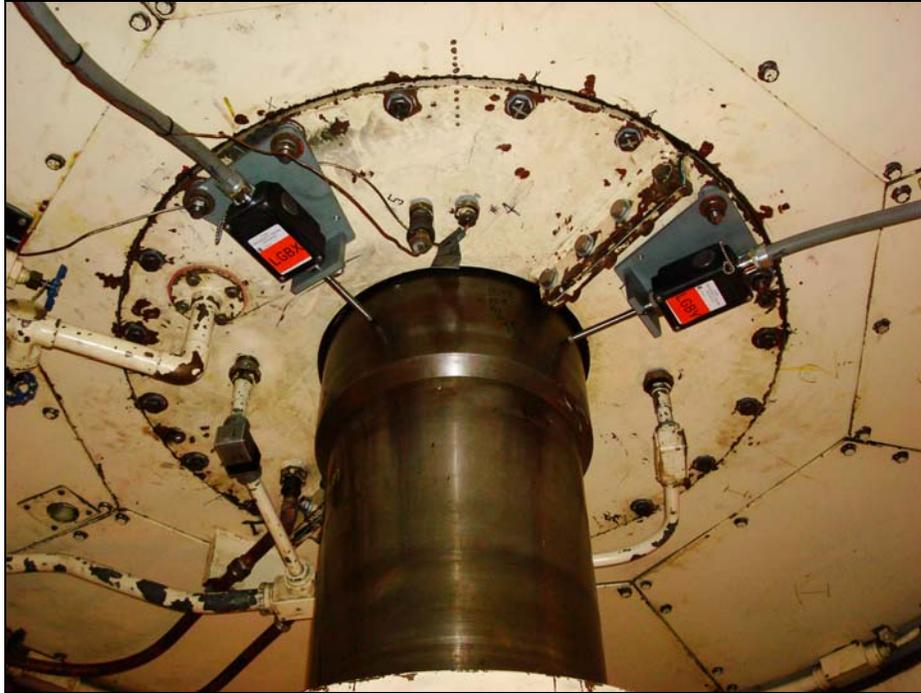
Fig 10: New X/Y Probes fitted to LGB Cover

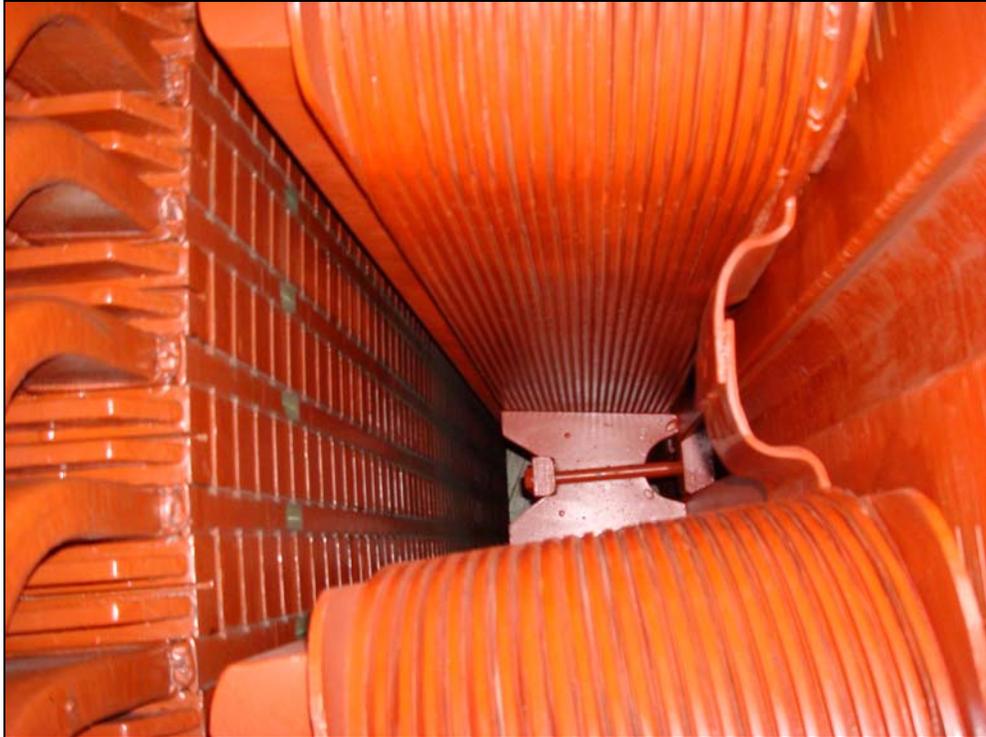
*Fig 11: Inter-pole gap looking down
Rotor to the right, stator to the left*

In the final analysis, the rotor being in place helped us by giving a solid surface against which the specially designed and manufactured expander tool could push to hold the probe in place against the stator.

However, it was a somewhat tricky operation to engineer the inner surface of the stator on which to bond the air gap sensors. Located at 8-10 inches below the top edge of the stator in between the pole pieces of the rotor, it was necessary to prepare the surface to accept the sensor, by removing the varnish and de-grease the surface. In this very limited space, working well below 'foot' level, the Air Gap sensors were then maneuvered into position and clamped in place; dust sheets and lanyards were used to secure anything which might drop, since extraction would have been difficult!
